# CRIME PREVENTION THROUGH ENVIRONMENTAL DESIGN ASSESSMENT

## SELECTED WATERCOURSE & RIVER AREAS

(Recommendation 115, Seven Youth Inquest)

Thunder Bay, Ontario

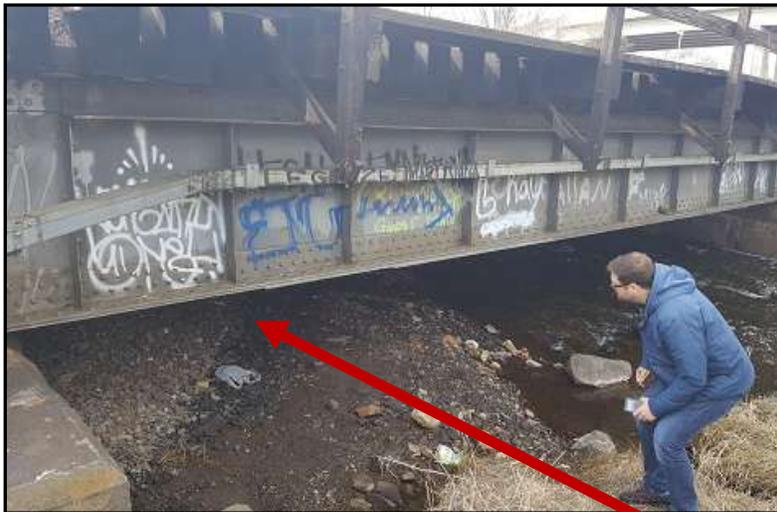
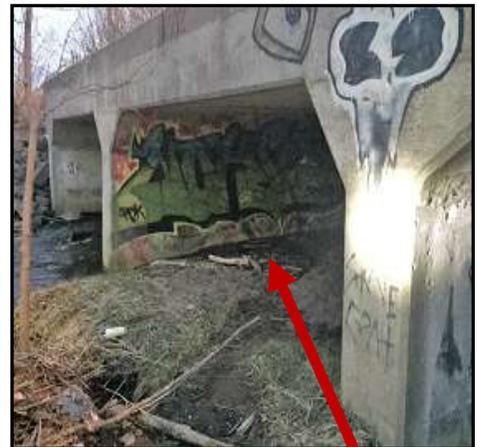
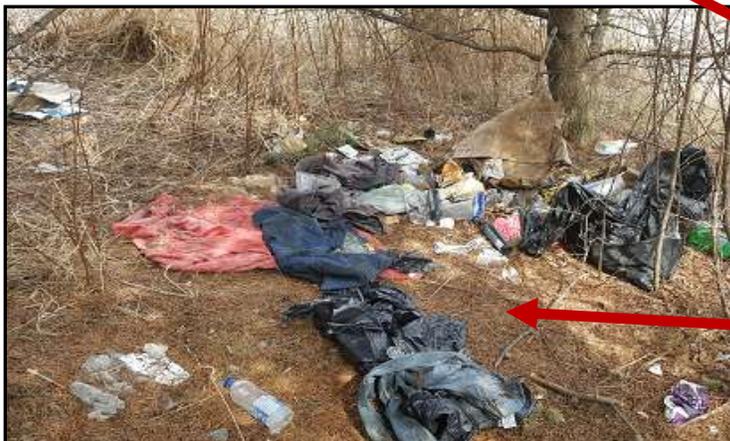
1. Rail and road bridge and tunnel structures offer ideal conditions for the long term sustainment of loitering
2. Patches of thick tree cover are often targets for impromptu campsites to facilitate loitering

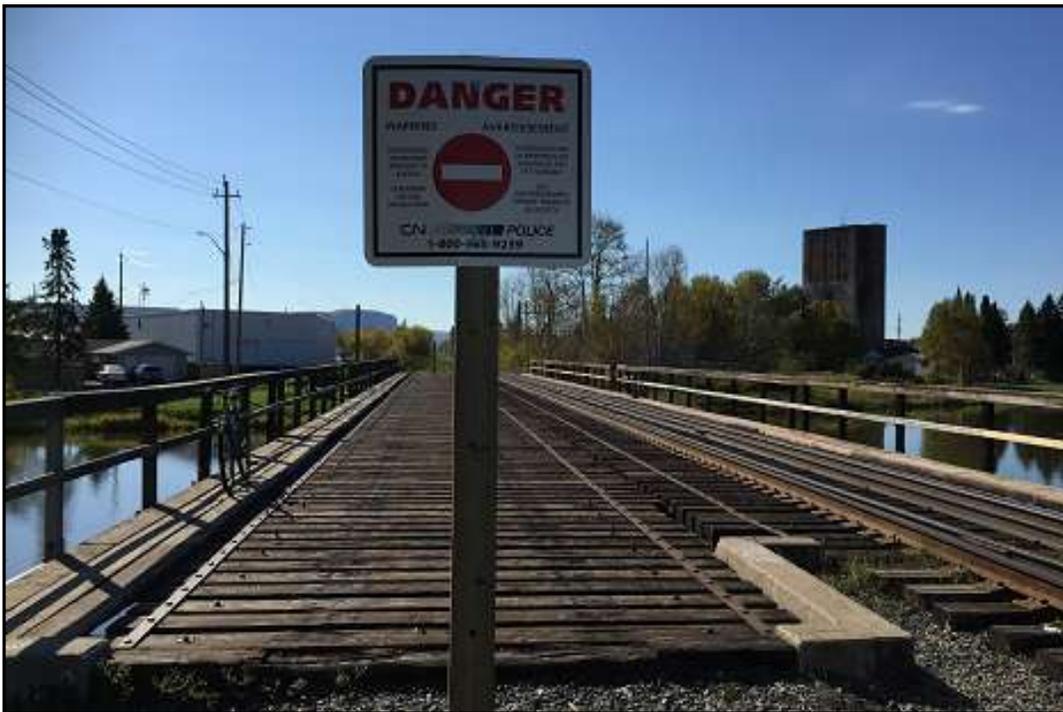
Informal paths alongside some of the waterways connect to rail bridge crossings which are not intended nor designed or legally permissible to accommodate regular, safe pedestrian passage. These bridges have very little space for a pedestrian when there is a passing train, placing the trespassing pedestrian in great danger for harm. Because these rail structures invariably offer a convenient way to cross the river, they become targets for individuals to use, albeit unlawfully. This needs to be addressed.

**Rail bridges such as the one pictured here are not designed or intended to accommodate safe pedestrian passage and any action as such therefore represents trespassing**

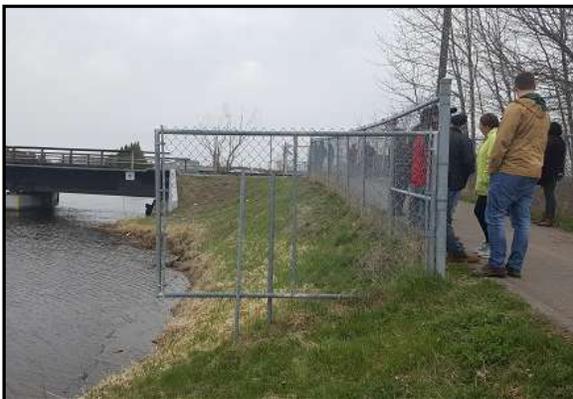
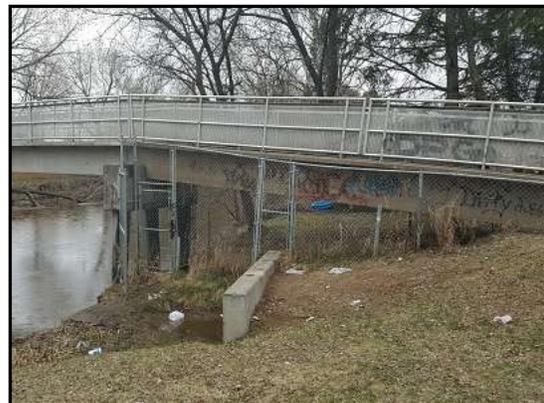
**Efforts have been made to physically restrict accessibility to higher risk areas under built structures such as bridges using fence partitioning**

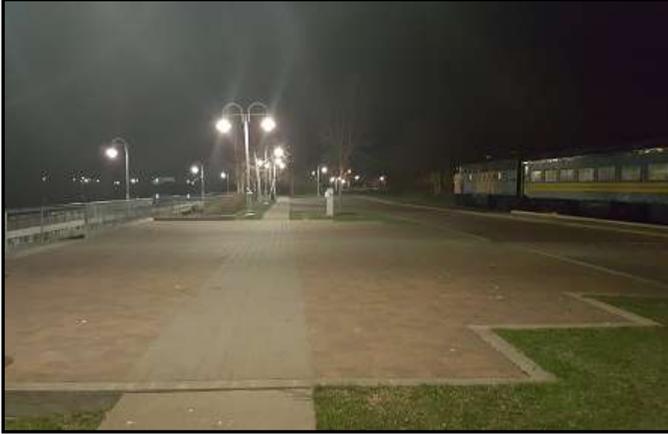
- A number of sections have lighting provided that offers enhanced visibility during non-daylight hours. This permits good, ongoing natural surveillance of the space, even during periods when observation capability is reduced (i.e. night time), elevating the feeling of safety for users.

**When light quantity is adequate and evenly distributed, it elevates user safety**

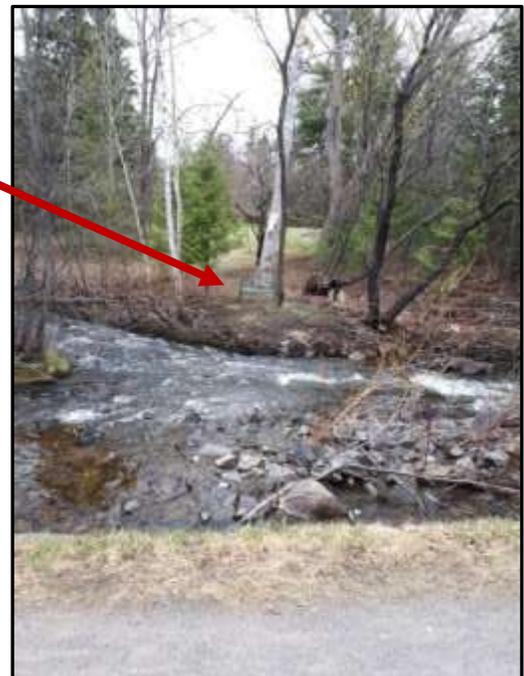
- 1. Open view corridors to some sections of the natural environments create situations whereby neighbours effectively can become “guardians” that watch over the space**
- 2. Park bench on private residential property observing trail and river**
- 3. Picnic tables on private commercial property with great visibility of the trail and river**

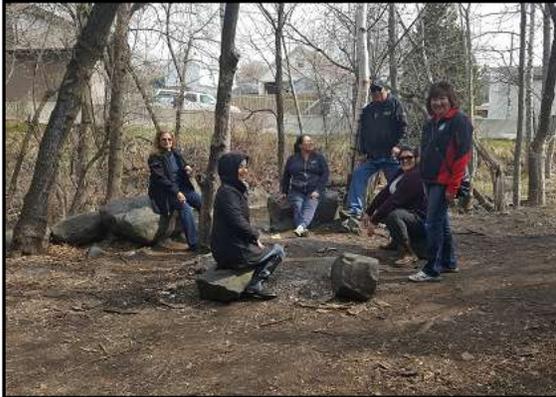
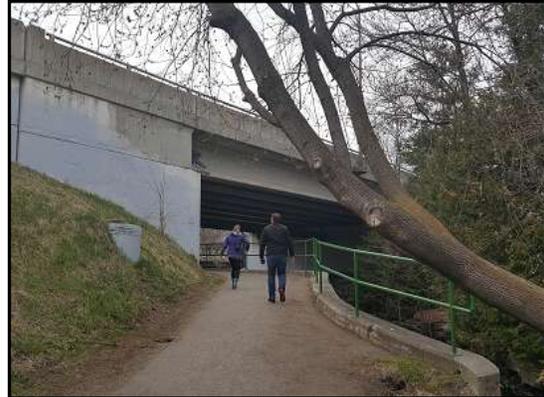
**River-based natural areas are highly unique, valued community assets for any municipality and accountable usage of them will help promote “eyes-on-the-river”**

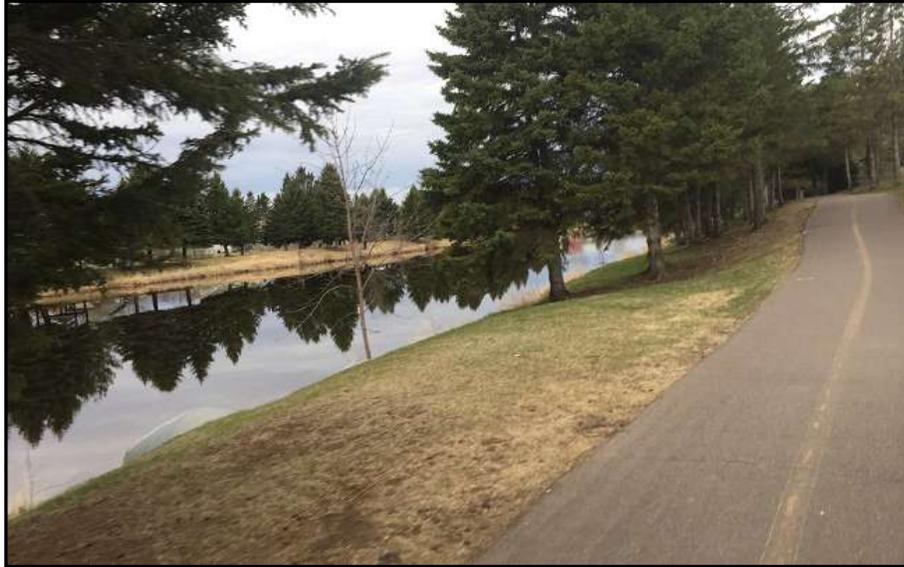
**More isolated sections of river environments promote higher risk and potential for harm due to less ongoing natural surveillance capability**

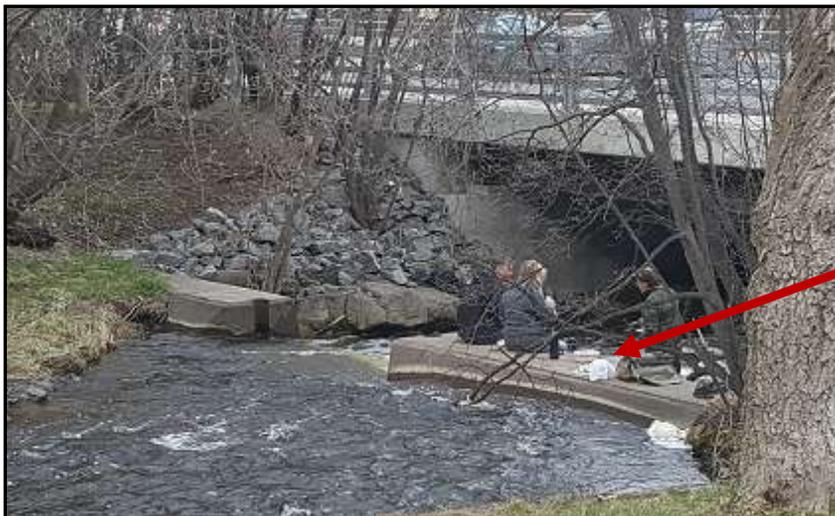
**Concrete structures facilitate sitting and open consumption of alcohol**

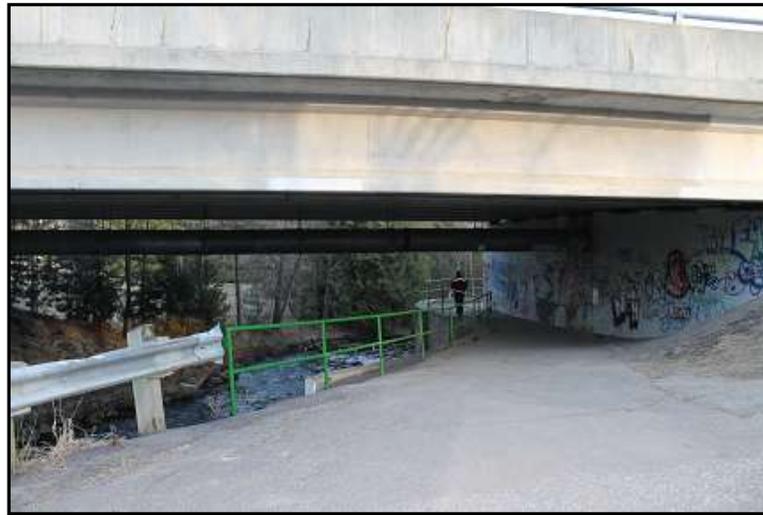
- Large, "vault" style tunnels filled with graffiti, empty liquor bottles, needles, discarded clothing, etc. - this is strong evidence these discrete spaces are being regularly used for long term loitering and are very difficult to observe easily.

**Trail and creek's path underneath Algoma Street Bridge is somewhat confining and unsafe with unlawful behaviour evidenced by extensive graffiti**

**High intensity motion-activated floodlighting should be installed here to effectively illuminate the underside of the Algoma Street Bridge**

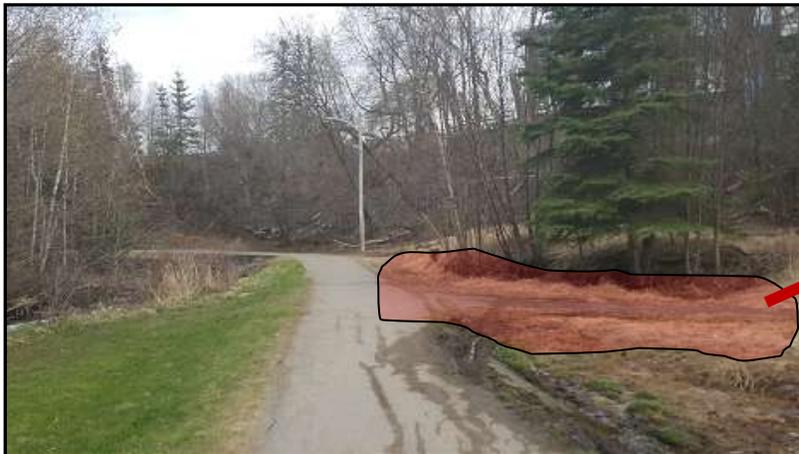
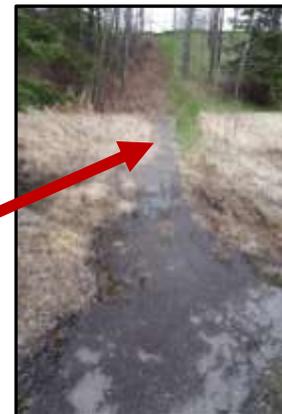
**Former paved path is now redundant and leads to a shrouded, discrete area**

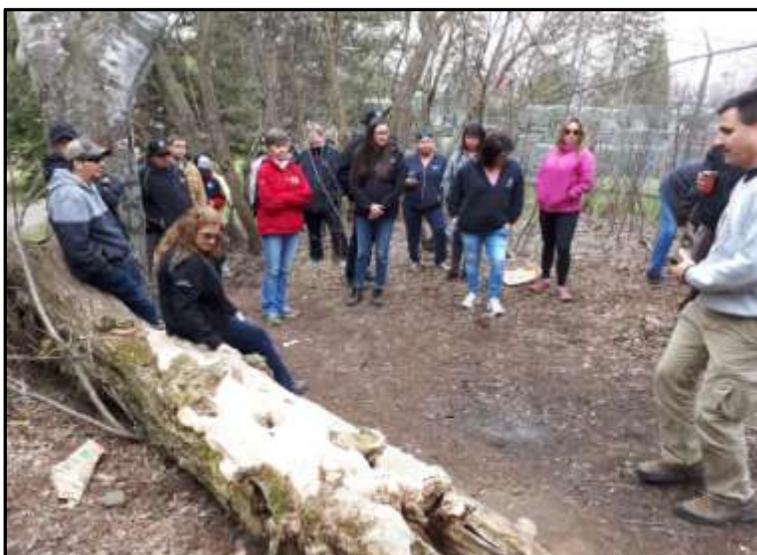
**Fallen trees have become converted to seating areas for loiterers to take advantage – these are often situated in discrete pockets making them difficult to detect. Removal of these “campsite” features helps eliminate opportunities for loitering to establish.**

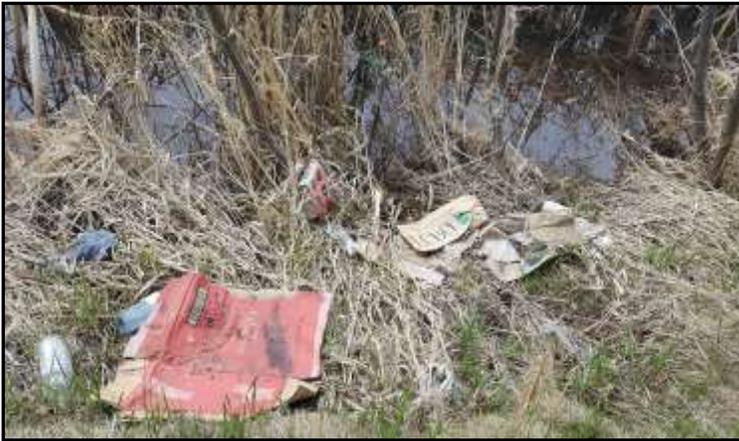
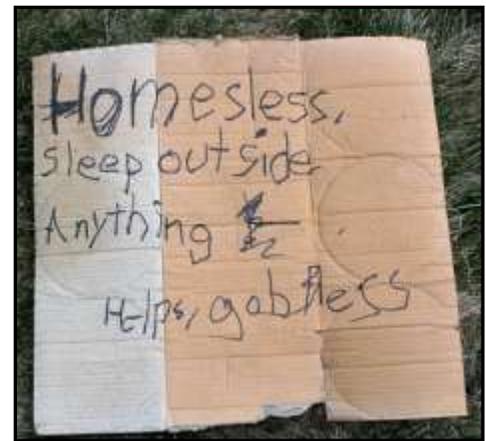
**Heavy quantities of litter, trampled vegetation, and empty liquor bottles line the bank of the Neebing-McIntyre Floodway behind the LCBO, reinforcing the unfortunate reality that unlawful behaviour thrives there**

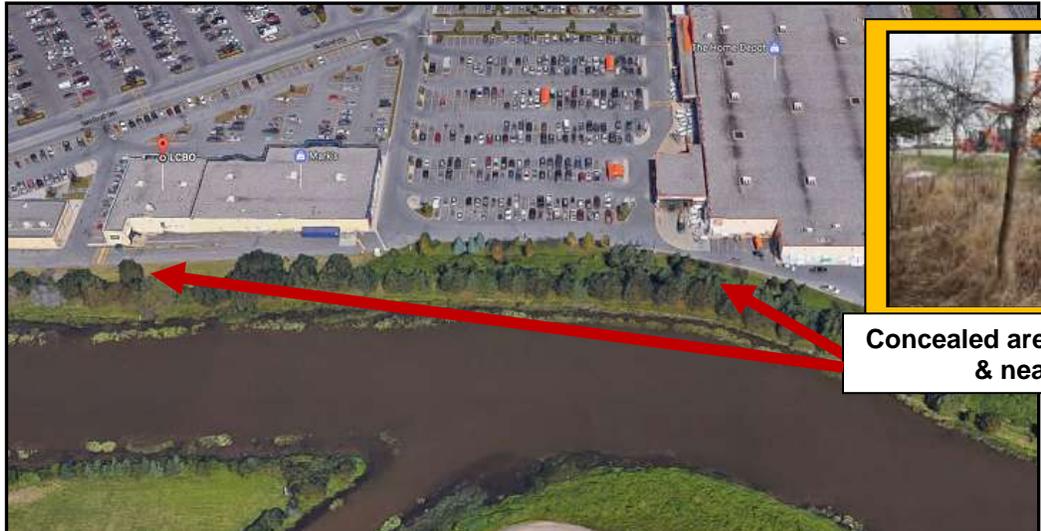
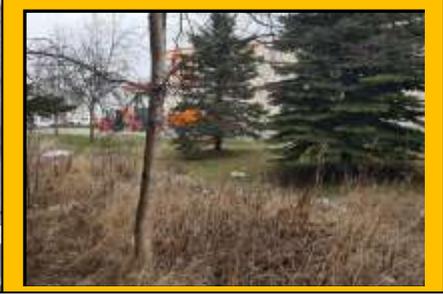
- A large section within this Study Area is located directly behind a major commercial plaza but of note is this section of the river is "back-of-house" to the very busy plaza, resulting in minimal natural surveillance capability from plaza users. Despite its close proximity, the lack of directly oriented sight lines effectively creates a "visual isolation" of this expanse of the river, elevating risk of harm substantially.

**Concealed area behind Home Depot & near LCBO store**

**Risk along this area of the river is elevated due to abutting businesses facing the opposite way. This means no ongoing observability occurs.**

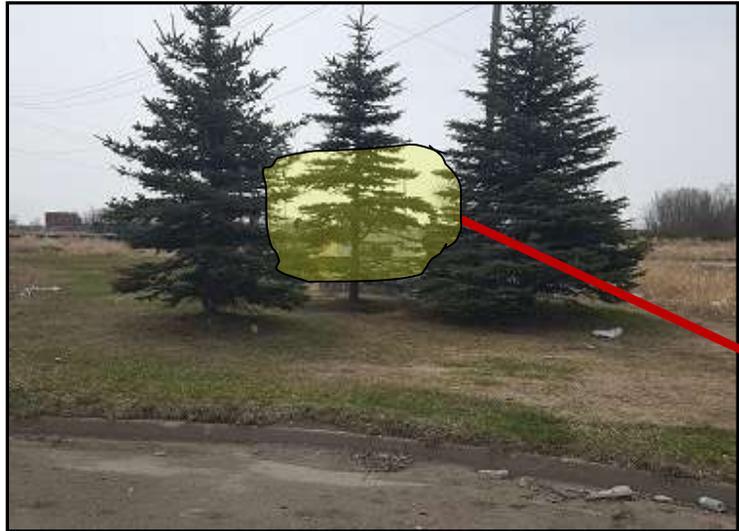
- Electrical transformer appears to be a popular hangout - as evidenced by heavy graffiti, liquor bottles, needles, etc. and the transformer is heavily shrouded by large, mature coniferous trees clustered together which block sight lines.

**Concealment of transformer facilitates unlawful activity**

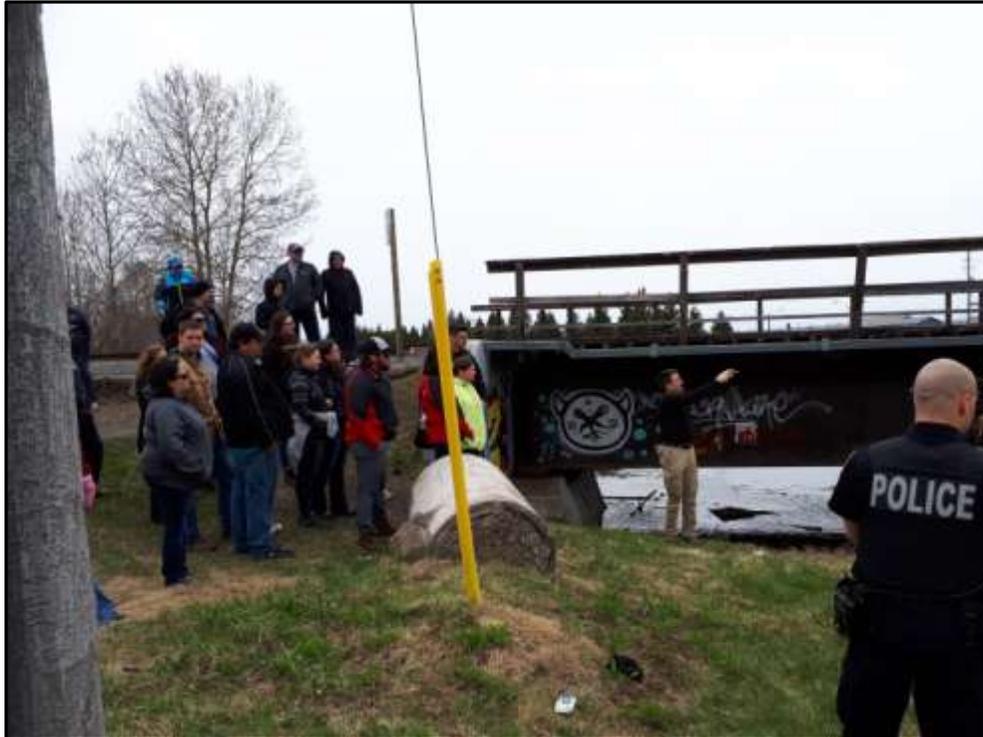
- CN Rail bridge crossing behind the Shoppers Drug Mart has considerable evidence of trespassing and loitering (extensive debris build up and graffiti).

**Extensive graffiti and debris build up signify sustained long term loitering**

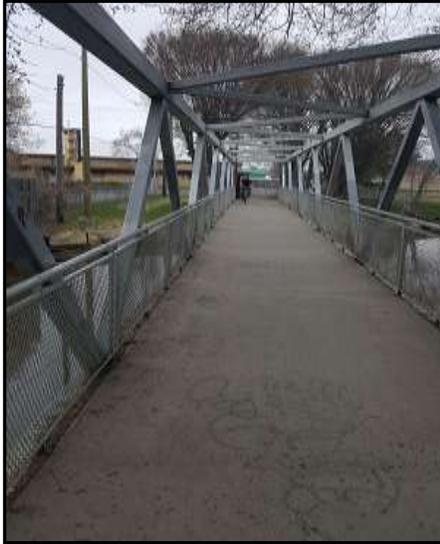
- Pedestrian bridge is covered in graffiti - both on the crosswalk path, plus on the sides and underneath on both sides at the river's edge. This is a clear sign that sustained unlawful behaviour is occurring here.
- At the time this area was inspected, three youths were observed drinking alcohol on the bridge at 3 pm.

**Needing River pedestrian bridge has a considerable amount of graffiti. This is both an open sign of unlawful behaviour and a deterrent to usage by lawful users.**

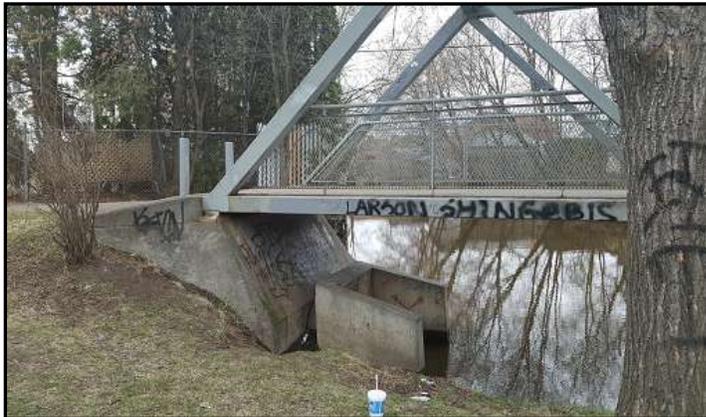
- The sides of the bridge on one side have been modified with chain link fence partitioning to prevent access to the underside of the bridge ....but this has only been done on one side which does not prevent access entirely.

**Open access facilitates loitering**

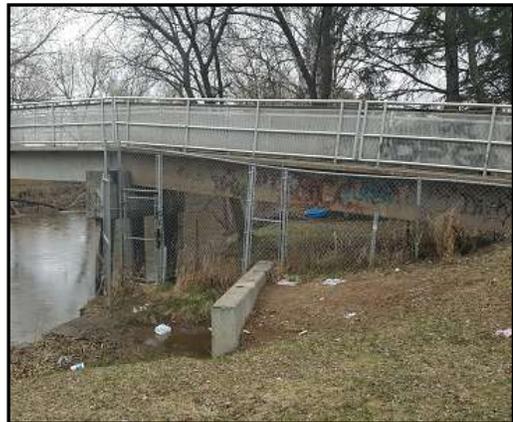
**Closed access prevents loitering**

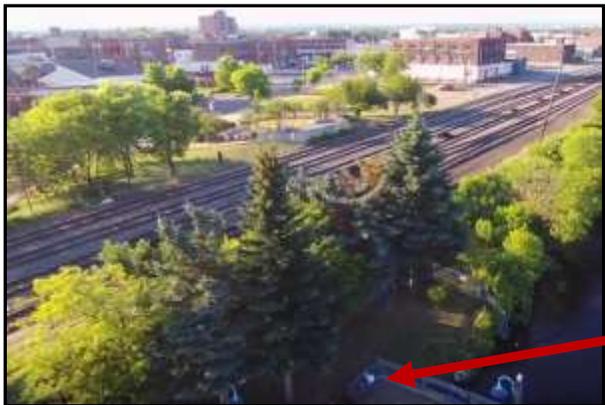
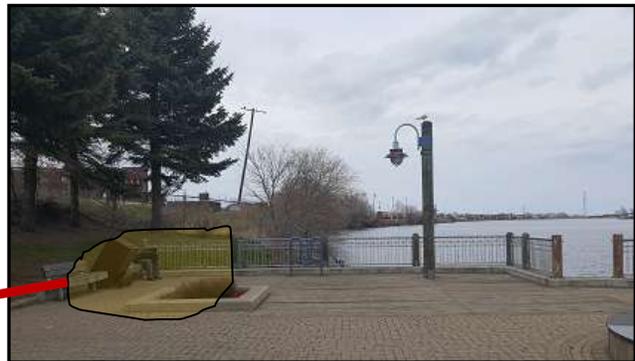
- Many areas exist where anyone can easily fall into the river. Intoxicated individuals are at greatest risk. In fact, a highly intoxicated person, alone and in close proximity to the river, was encountered in this location during a pre-audit inspection at 5 pm on May 15<sup>th</sup>, 2017. Numerous pockets of unobservable space exist where individuals can become positioned undetected, greatly increasing the probability of harm either by accident or triggered by a criminal act.

**The highly secluded physical environment along the Kaministiquia River creates vulnerable circumstances that elevates the probability for harm to occur**

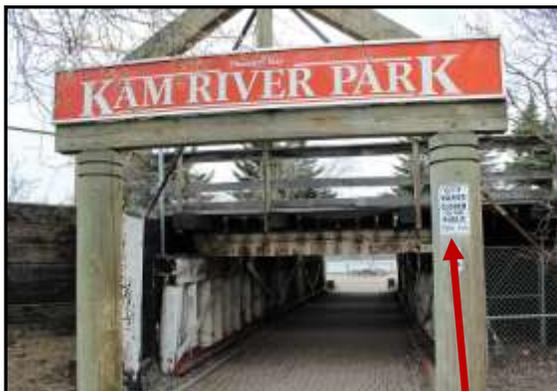
- Pedestrian tunnel is supposed to be closed from 11 pm until 6 am daily (a sign at the entrance to the pedestrian tunnel states this); however there is no physical closing off of this access point during these hours. One positive point is the tunnel is very well illuminated, optimizing visibility at night.

**Pedestrian access stays open despite sign**

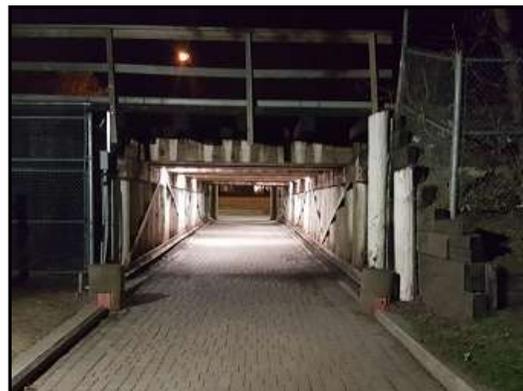
**But tunnel is well lit for evening visibility**

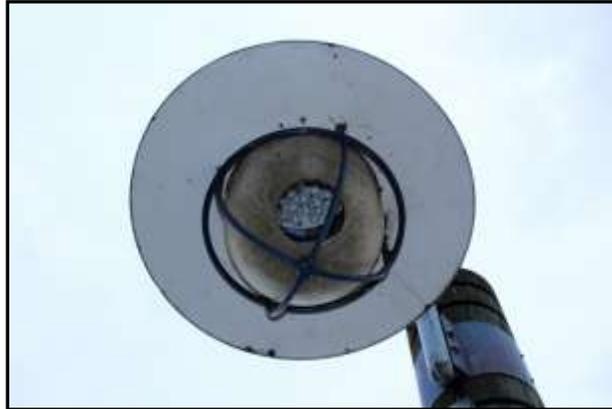
- Light fixtures are more of an ornamental type that seem intended to exude a "nautical" theme to match the waterfront location; there appears to be LED lights inside the frosted fixture covers.....plus fixture covers are cloudy/dirty with dead insects inside of them - this blocks a discernible quantity of illumination output.

**Existing light fixtures are less practical for optimizing light output and need improved maintenance**

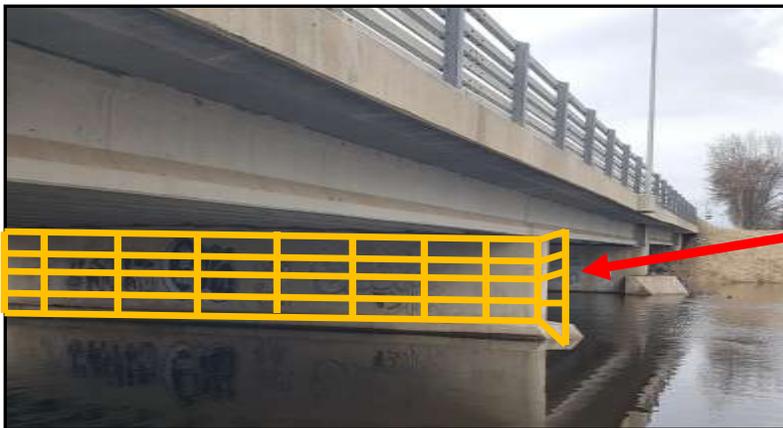
**In this location, simply eliminating the access to the ledges that form part of the structural base of the bridge may be all that is needed to prevent access**

- Installation of motion-activated flood lighting, complete with industry standard vandal guards, to be installed on the underside of bridge and tunnel structures very close to the edges yet inside any installed steel partitioning. The lights will be triggered by activity from anyone attempting to attend near the hidden spaces around these structures.

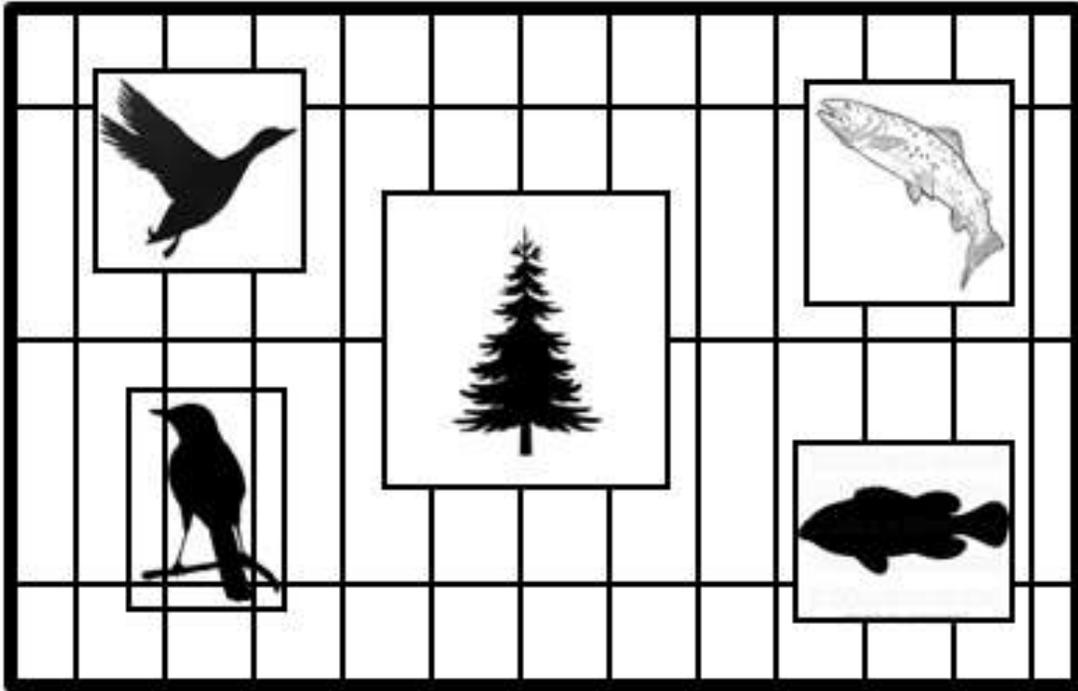
**Conceptual design suggestion of what a secure partition could look like to be used to restrict access to the underside of bridges. All materials shown would be of corrosion resistant steel to offer maximum security but with an artistic element that respects these natural areas**

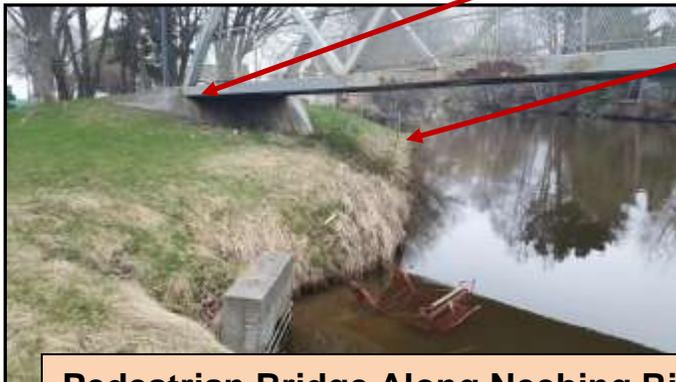
**Pedestrian Bridge Along Neebing River**

**An artistic steel grate properly positioned can deter physical access that triggers unsafe activity**

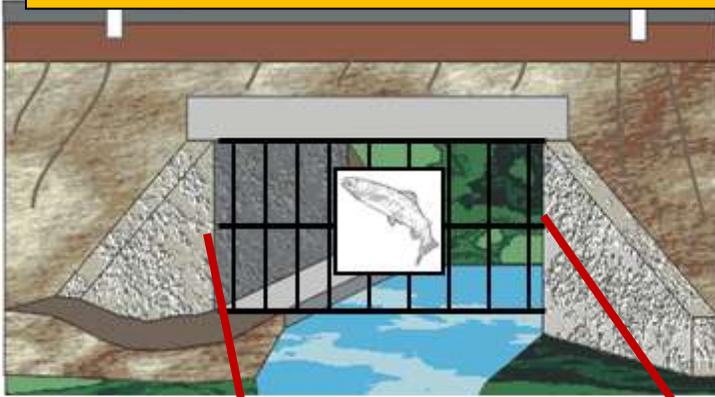
Tunnels like this one show very clear evidence of long term loitering and therefore increased risk for harm. Easy access into these highly discrete spaces needs to be removed through the use of art inspired decorative grates

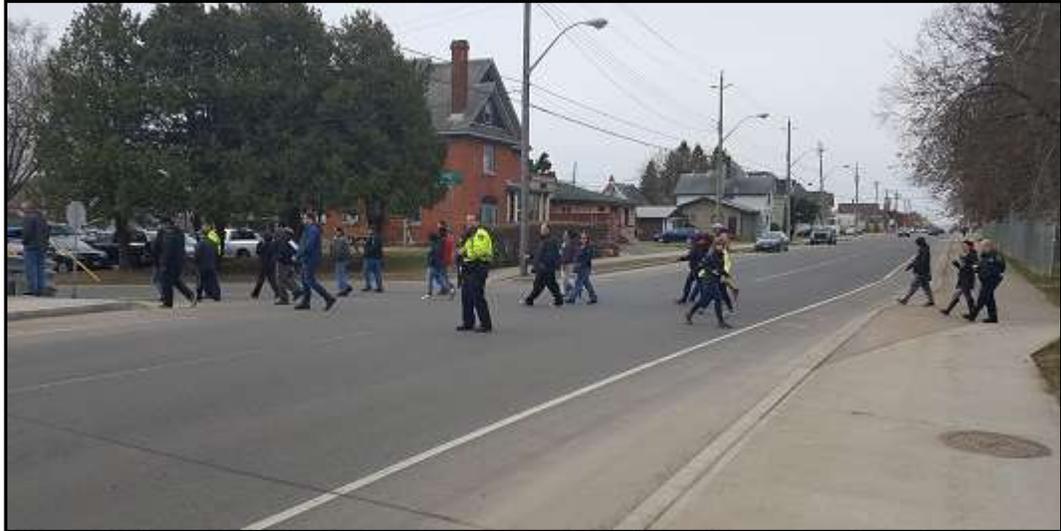
**Pedestrian crossing of Court Street needs proper pavement markings, lighting, and signage to alert drivers for improved pedestrian safety**

**RECOMMENDATION:** This road crossing point, and all others with a similar context, should have very pronounced treatments to properly alert drivers to the presence of cyclists and pedestrians. A combination of highly visible pavement markings with advanced warning signage and enhanced lighting should be installed, at a minimum, to improve safety for trail users. If safety remains a concern, a traffic calming application may be worth exploring (such as a speed table) to reduce vehicle speeds for safety.

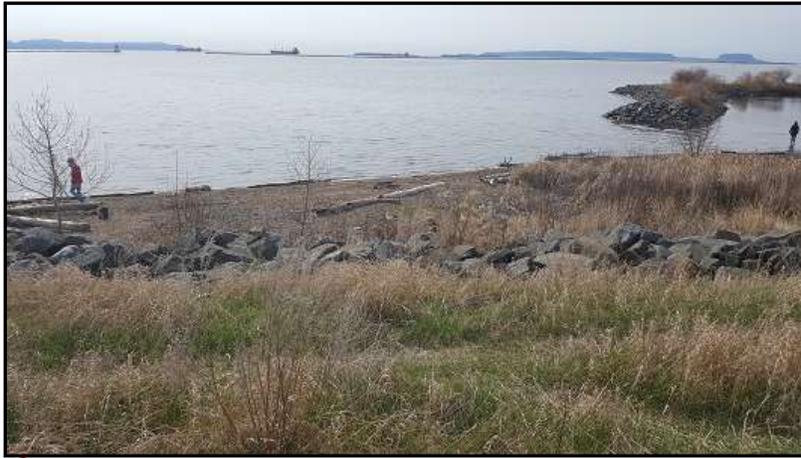
The fact is.....this is an aesthetically significant section of this natural environment culminating with the confluence of McVicar Creek with Lake Superior. This is ecologically unique and valuable and warrants a deliberate process to “celebrate” it through a proper connection that will allow a greater number of lawful users to access the area on an ongoing basis.

The natural vista that exists where McVicar Creek reaches Lake Superior is uniquely beautiful to Thunder Bay and greater accessibility of it should be pursued

The recommendation here is for the City of Thunder Bay to conduct and oversee a formalized design review process to explore physical pedestrian connection options to this space from the nearby Marina Park area that is immediately adjacent. It is acknowledged there is a notable physical topography challenge that exists for making any connection but the outcome value to be gained is worth going through the process of exploration. Full public input into this process is critical to identifying a potentially successful design solution. The Marina Park area already attracts many users so a connection here would be logical and beneficial to everyone. If successful, the primary safety benefit of such a connection would be a significant increase in ongoing, random, positive activity generation...***a phenomenon that is a proven criminological “vaccine” for eradicating loitering and other negative behaviour.***

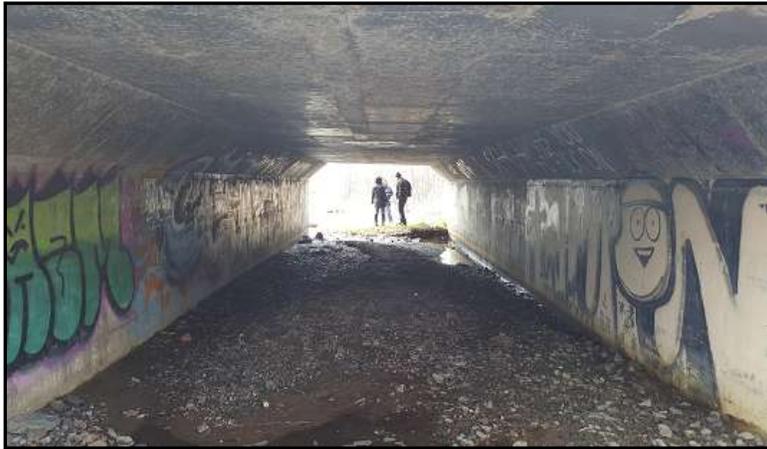
**All situations of graffiti openly portray unlawful activity and must be dealt with promptly**

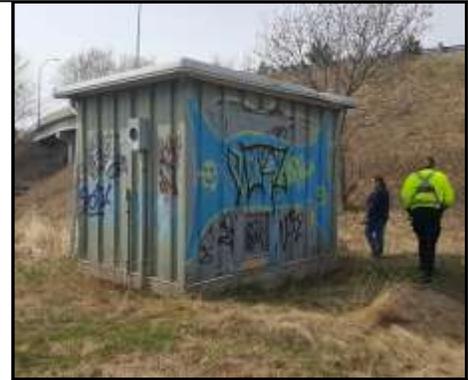
The physical assessment revealed numerous locations throughout the Study Areas where graffiti was prominently visible. This is a clear sign of sustained unlawful behaviour, the look of which reduces a lawful user's perception of safety and comfort. Therefore, any visible signs of graffiti need to be addressed promptly as soon as they are discovered. The ideal way to do this is to clean it up right away after discovering it.....each and every time this occurs. Attacking it in this fashion sends a message to perpetrators that such behaviour is not tolerated and that someone is in care and control of the space. An additional measure to consider is to apply a coating of a commercial grade, anti-graffiti clear coating to any physical element that is susceptible to graffiti (such as garbage cans, sides of bridge structures, signs, benches, etc.). The clear coating makes for much easier clean up of any acts of spray painted graffiti on an ongoing basis. Exceptions would be any areas approved for works of sanctioned, commissioned public art.

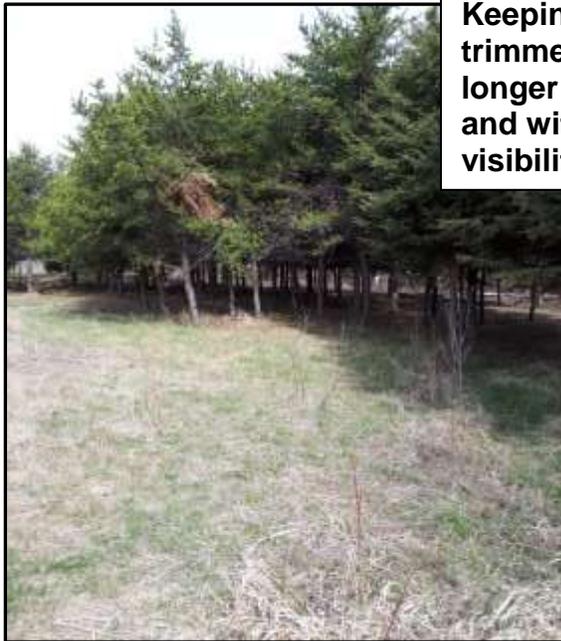
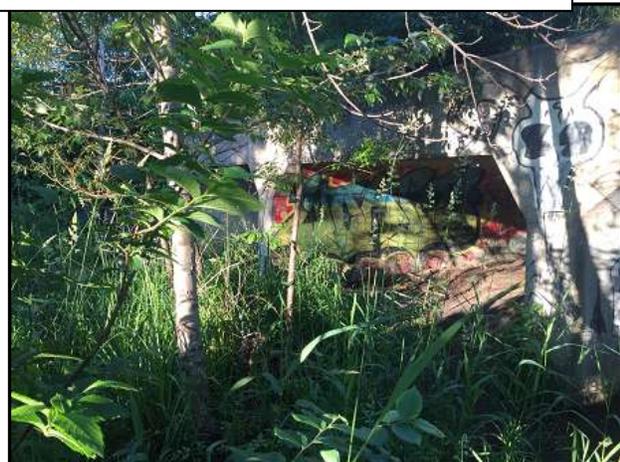
**Keeping underbrush and low branches trimmed where possible will help to maintain longer lines of sight, which elevates visibility and witnessing potential (left). If not, visibility is greatly diminished (below)**
